TEST REPORT

STATIC STRENGTH TESTING OF *UNIVERSAL SAFETY ANCHOR*

J7341.01-119-42 R0

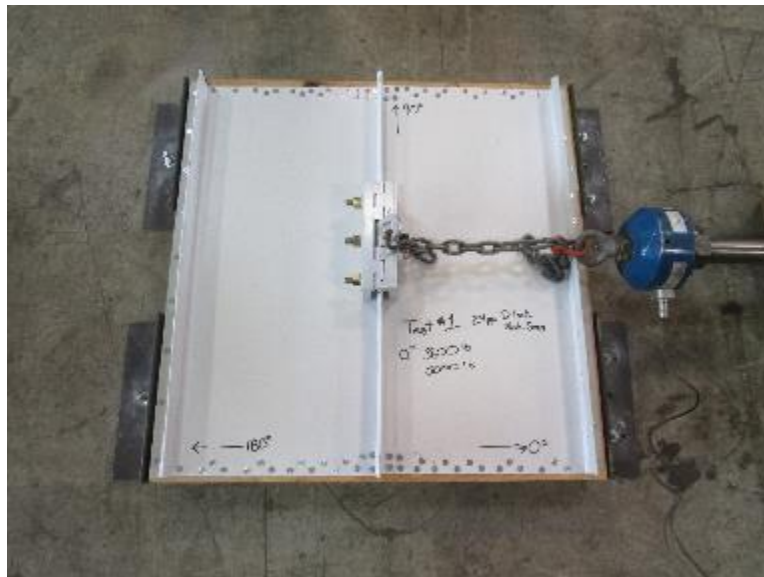
Photo No. 1

Typical Setup for Test Perpendicular to Direction of Standing Seam Roof

Six specimens were individually installed onto the seam of the standing seam roof and each bolt was torqued to 70 ft-lbs. A hydraulic cylinder with a load cell capable of reading 25,000 lbs. was attached to the safety D-ring of the anchor. Section (c) (8) of OSHA 1910.140 specifies that “D-rings, snaphooks, and carabiners must be proof tested to a minimum tensile load of 3,600 pounds without cracking, breaking, or incurring permanent deformation,” therefore, three specimens were loaded to 3,600 lbs., perpendicular to the direction of the standing seam roof, and three specimens were loaded parallel to the direction of the standing seam roof. Section (c) (7) of OSHA 1910.140 specifies that “D-rings, snaphooks, and carabiners must be capable of sustaining a minimum tensile load of 5,000 pounds,” therefore, one specimen, in each direction, was also loaded to 5,000 lbs. The load was then released, and observations were noted. See photographs in Section 10 and drawings in Section 11 for more information.

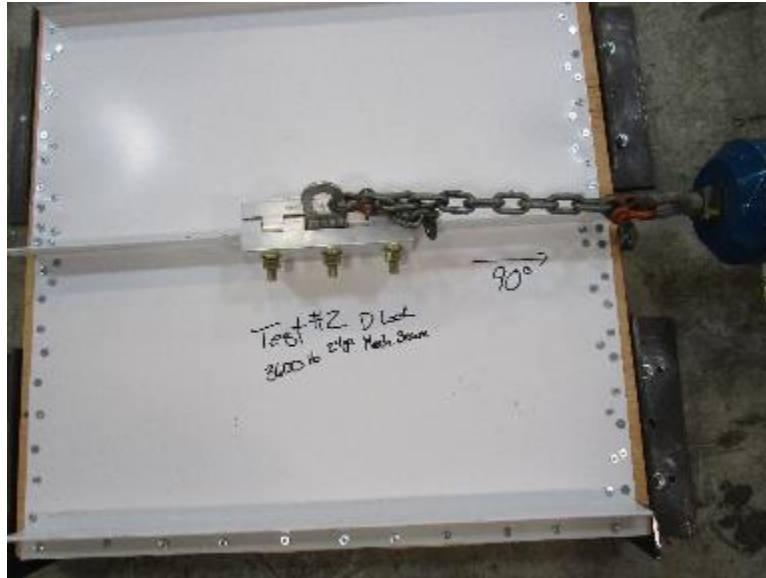
Photo No. 2

Typical Setup for Test Parallel to Direction of Standing Seam Roof

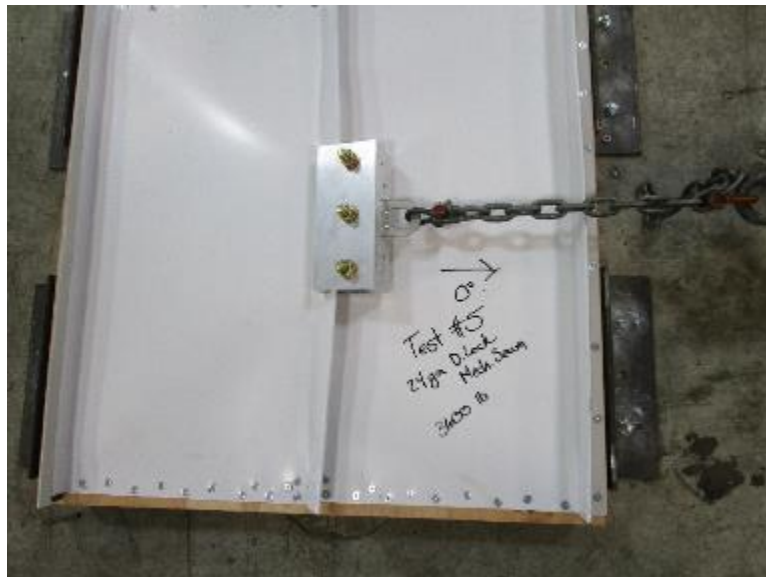
Photo No. 3

Specimen at 3,600 lbs. Perpendicular to Direction of Standing Seam Roof

SPECIMEN NO.	TARGET LOAD (lbs.)	OBSERVATIONS
1	3,600	Achieved load equal to or greater than 3,600 lbs. without any signs of cracking, breaking or permanent deformation
	5,000	Achieved load equal to or greater than 5,000 lbs.
2	3,600	Achieved load equal to or greater than 3,600 lbs. without any signs of cracking, breaking or permanent deformation
3

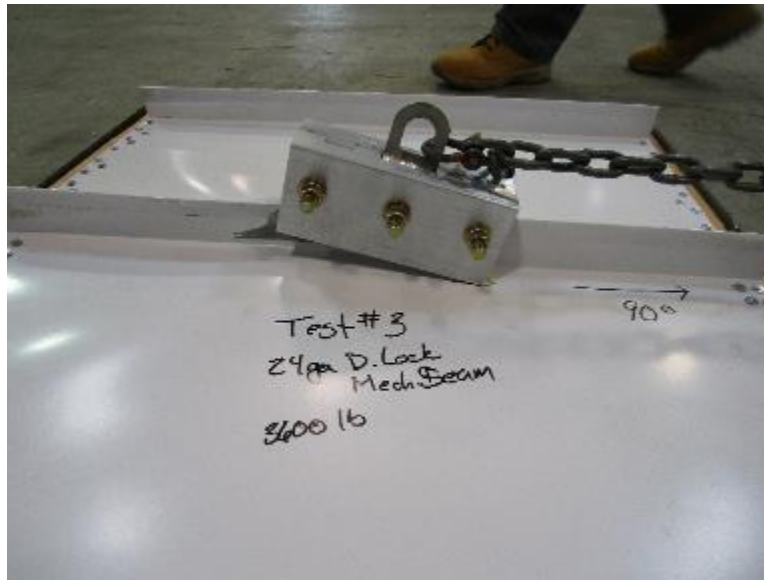
Photo No. 4

Specimen at 3,600 lbs. Parallel to Direction of Standing Seam Roof

SPECIMEN NO.	TARGET LOAD (lbs.)	OBSERVATIONS
1	3,600	Achieved load equal to or greater than 3,600 lbs. without any signs of cracking, breaking or permanent deformation
	5,000	Achieved load equal to or greater than 5,000 lbs.
2	3,600	Achieved load equal to or greater than 3,600 lbs. without any signs of cracking, breaking or permanent deformation
3

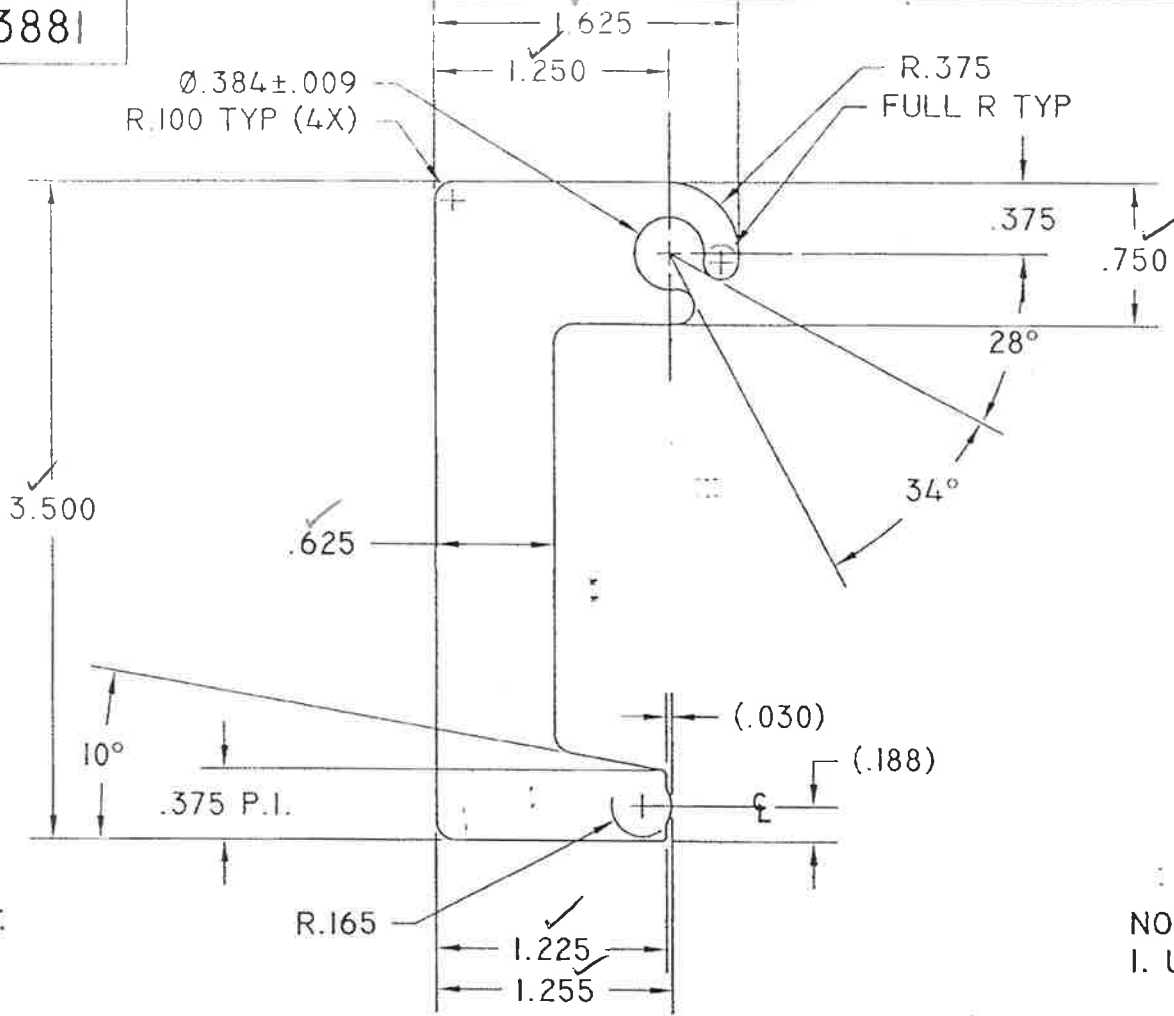
AREA: 2.983	CUSTOMER: METAL PLUS	
PERIM: 11.946	PART NAME: FALL PROTECTION MALE	DATE: 01-03-19
OUTSIDE PERIMETER: 11.946		DWN BY: MRB
WT./FT. 3.579	CUST DWG /REV FALL PROTECTION MALE	SCALE: 1 : 1
MAT'L: 6061-T6	SECTION No. 903881	CHK:

A two-piece hinged aluminum mechanism 2-1/2 in wide by 3-1/2 in tall by 8 in long. Each piece is 5/8 in thick and is held together with a 0.391 in diameter hinge pin. The inside dimensions when closed are 1-1/4 in wide by 2-1/2 in tall. The safety D-ring is 304 stainless steel with an outside diameter of 2.104 in and an inside diameter of 1.243 in. The anchor is secured with three 1/2 in by 3-1/2 in long square head bolts (3.833 in overall length, 0.491 in major diameter, 0.425 in minor diameter, 0.738 in head diameter, die point) with an accompanying nut, lock washer, and washer. See Section 10 for photographs and Section 11 for drawings.

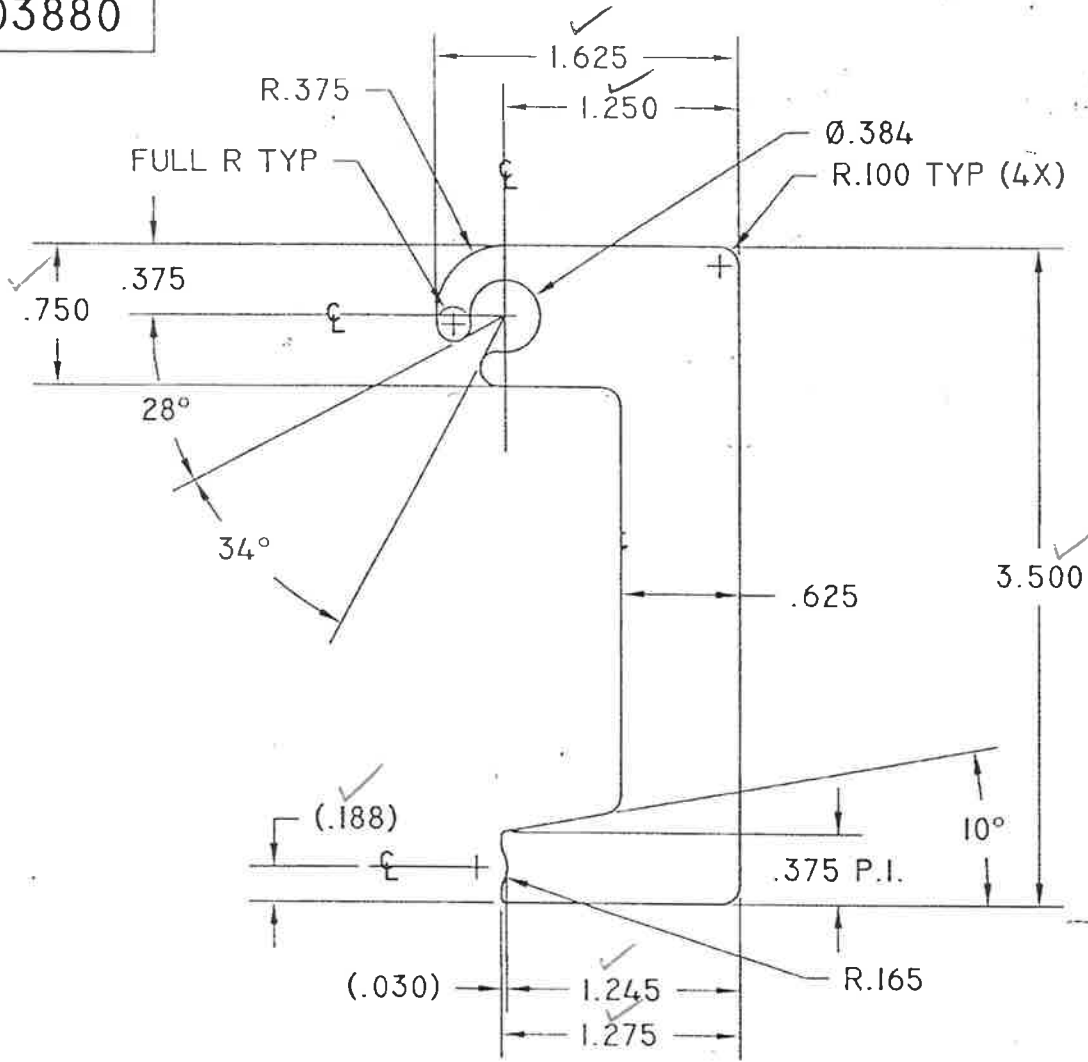
AREA: 2.999	CUSTOMER: METAL PLUS		
PERIM: 12.038	PART NAME: FALL PROTECTION FEMALE	DATE: 01-03-19	
OUTSIDE PERIMETER: 12.038		DWN BY: MRB	
WT./FT. 3.599	CUST DWG /REV FALL PROTECTION FEMALE	SCALE: 1 : 1	
MAT'L: 6061-T6	SECTION No. 903880	CHK:

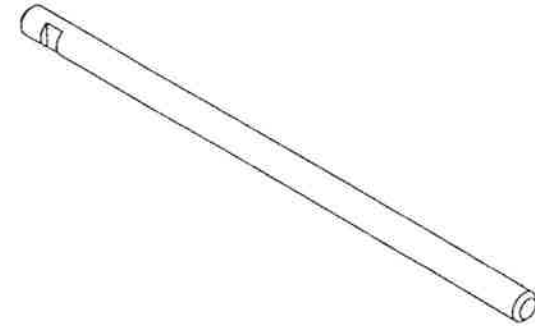
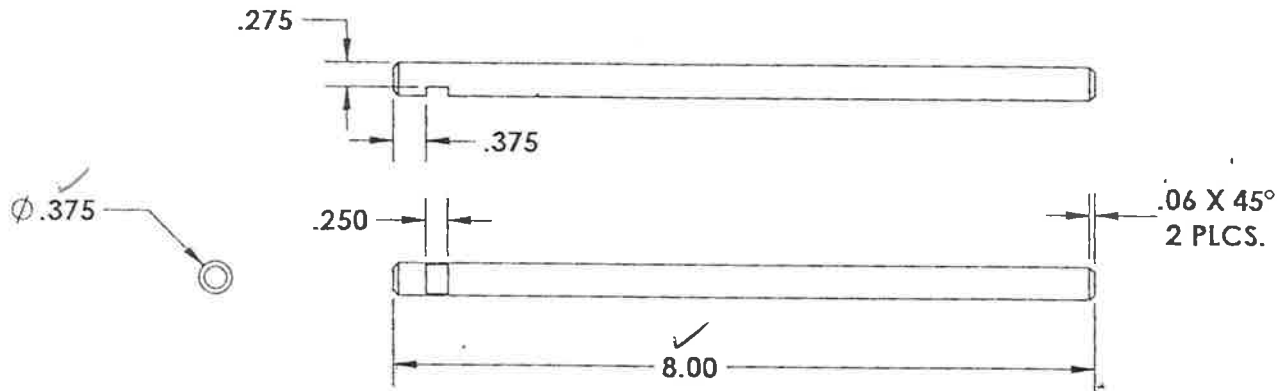
SIZE	DWG NO	REV
A	Hinge Pin 1	1
REV	DESCRIPTION	DATE
1	DESIGN STAGE	9/5/2017
		APPROVED
		XXX

MATERIAL	303 SST	MODEL	SKIP	9/5, 2017	TITLE METAL PLUS FALL PROTECTION		
FINISH	..	DRAWING	SKIP	9/5, 2017			
BEND TOOLING	..	CHECKED					
MADE FROM	..	APPROVED					
DATE:	9/5/2017	UNLESS OTHERWISE SPECIFIED: UNITS IN INCHES TOLERANCES: FORM/FIT/ASSEMBLY: XXX - DIA/XX - ROD FLAT PARTS (HOLE XXX - DUG/CR - DIA) ANGLES (X - 2)			SIZE	DWG NO	REV
SHEETMETAL DEPARTMENT		A	Hinge Pin 1	1	PROJECT	SHEET 1 OF 1
